Yellowstone Home Inspection, LLC - Sample Inspection Report

Home Description: Ranch, on Full Basement

Inspection Address: Street, City, ID

Date: October 31, 2015

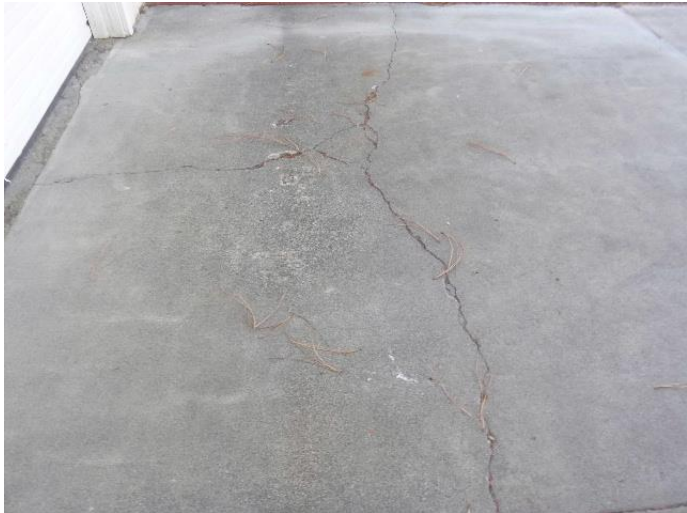
1	<p>Driveway:</p> <p>Type: Concrete .</p> <p>Condition: Cracks .</p> <p>Comments: Recommend monitor and consider sealing the cracks as needed to ensure longevity of driveway. .</p>

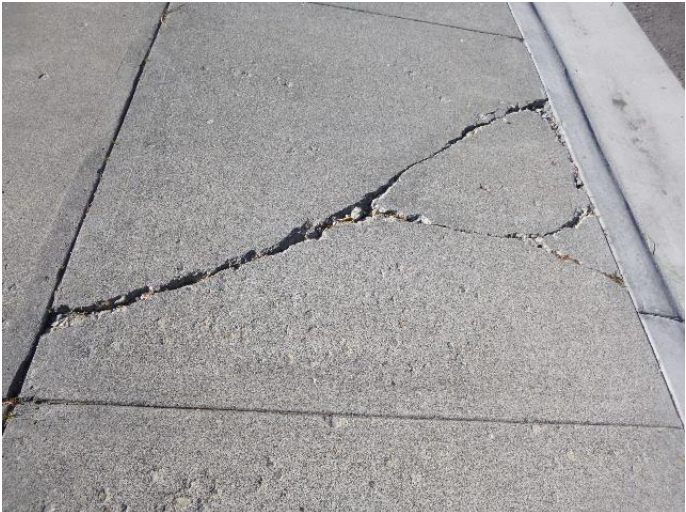
<p>2</p>	<p>Sidewalk / Walkways:</p> <p>Type: Concrete</p> <p>Condition: Settling Cracks Tree roots in the front have caused adjacent sidewalk to heave. This has created a possible trip hazard, due to raised edges. Recommend use caution, and to consider repair.</p> <p>Comments: Recommend monitor and consider sealing the cracks as needed to ensure longevity.</p>	<p>Minimal Concern</p>

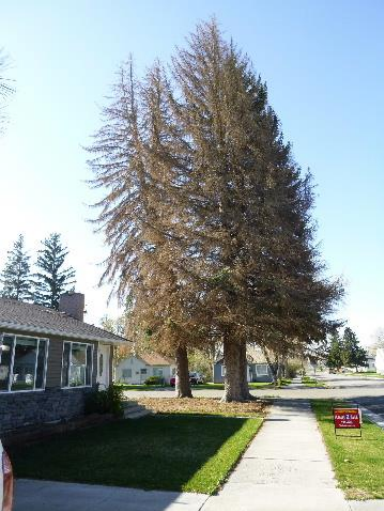
<p>8</p>	<p>Trees & Shrubs:</p> <p>Condition: Dead/ dying (2 in the front)</p> <p>Comments: Consider remove / replace</p>

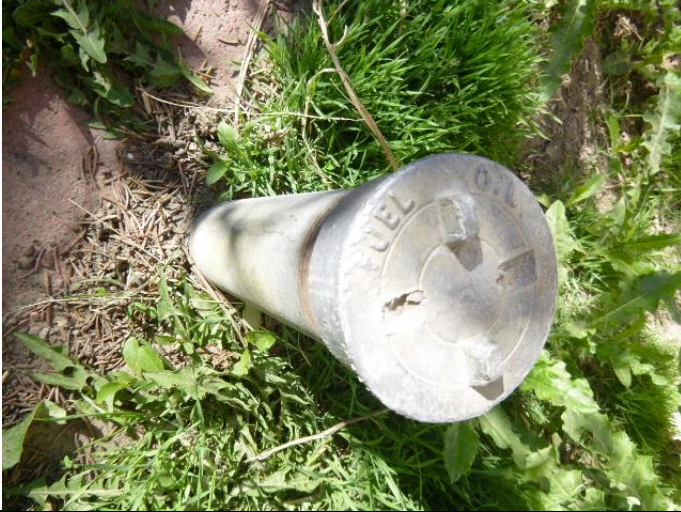
Concern: ***Possible underground fuel tank that is abandoned.***

Comments: ***These should be drained and backfilled with sand. Recommend check with present owner regarding status of the tank.***

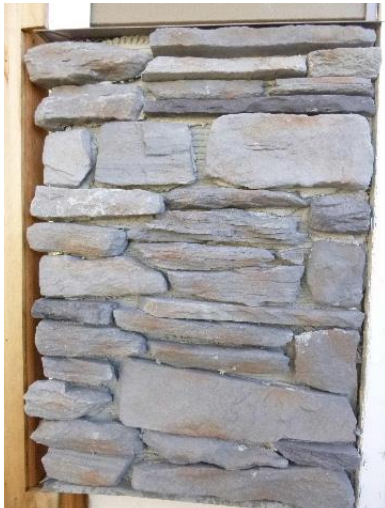
<p>1</p>	<p>Ground Contact With Wood: Type: <i>None Observed</i> Condition: <i>Good</i> Comments: <i>None</i></p>	<p>No Problem</p>
<p>2</p>	<p>Siding: Type: <i>Vinyl & Stonework</i> Condition: <i>Good , but the stonework is missing grout.</i> Comments: <i>Recommend finish the grout-work.</i></p>

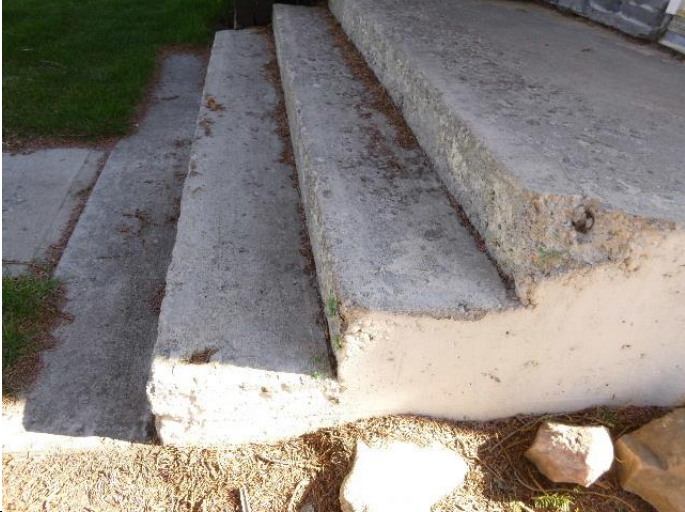
<p>7</p>	<p>Dryer & Exhaust Vent Outlets: Condition: <i>"Flapper" valve is stuck open.</i> Comments: <i>Consider cleaning/repairing the outlet valve. This will save energy in the winter by stopping backdrafts.</i></p>	<p>Minimal Concern</p>
<p>8</p>	<p>Front Steps: Type: Concrete Condition: Worn Comments: Consider repair of damaged section(s).</p>

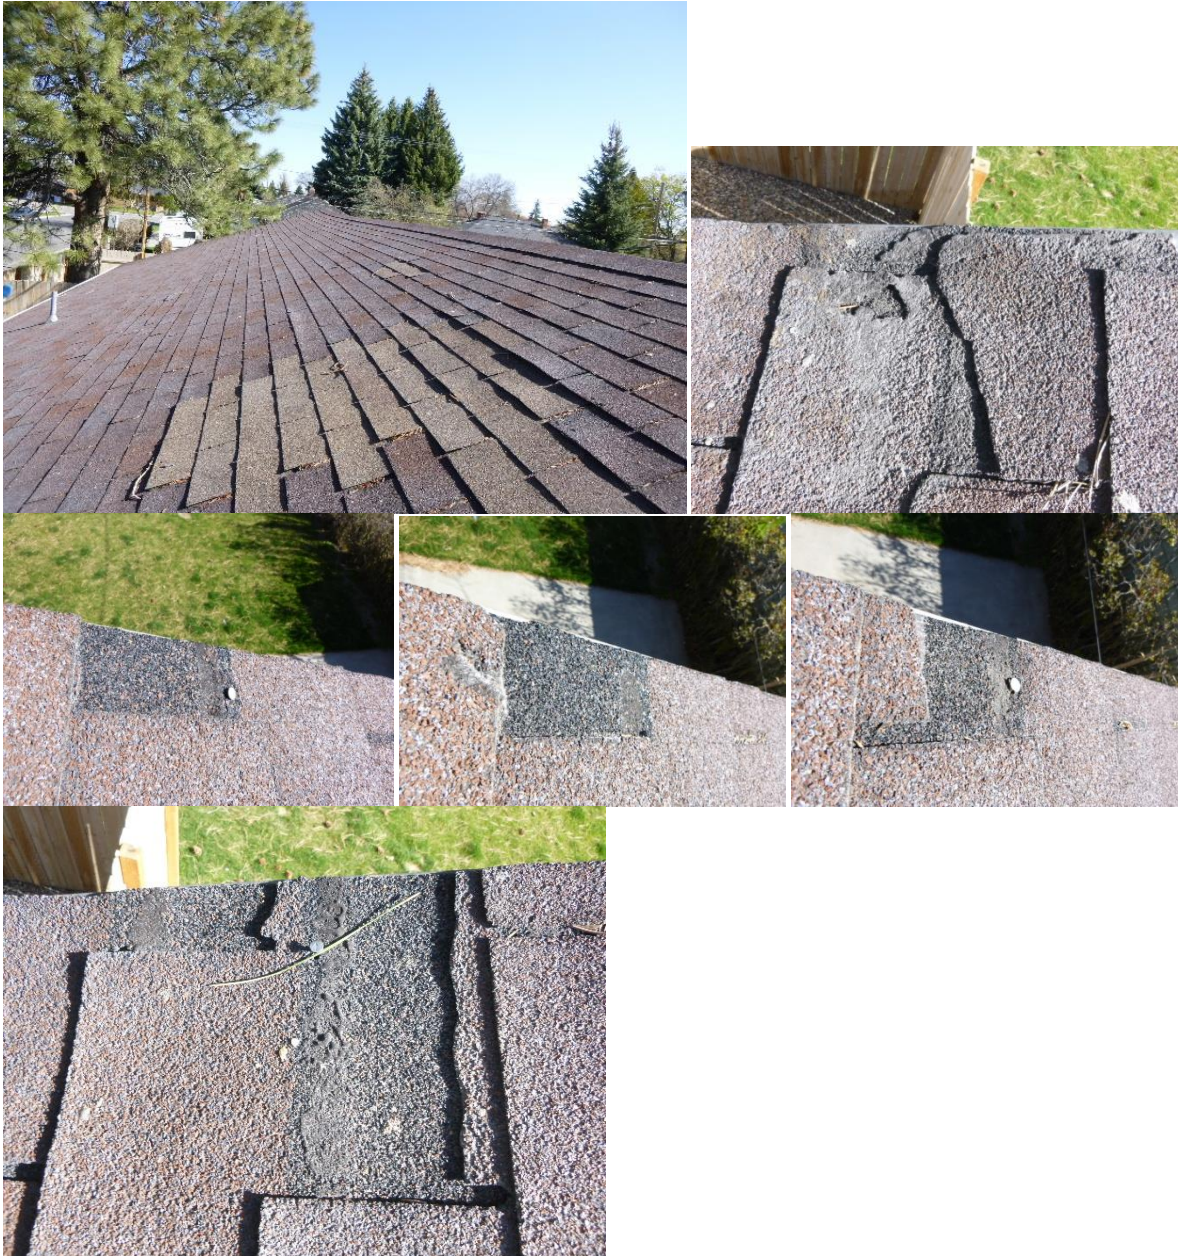
Condition: **Roof has a slight sag at the ridge above the garage. Attic inspection did not reveal any critical structural defects in this area. Recommend monitor**

The majority of the roofing appears to be in good condition, however there are some shingles that are damaged, and there is a patch on the west plane where a chimney once was.

Recommendations: **Recommend minor repair of roof where needed to maintain roof integrity.**

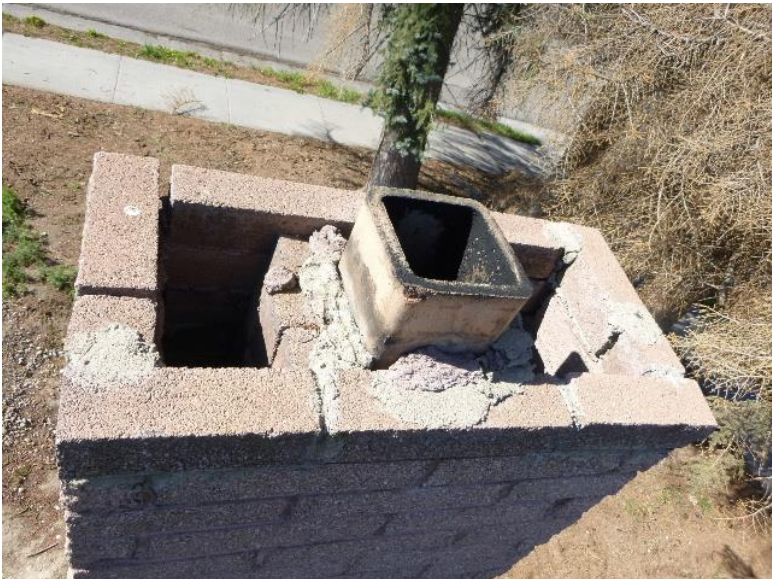
<p>2</p>	<p>Roof Sheathing: Condition: Good Comments: None</p>	<p>No Problem</p>
<p>4</p>	<p>Stack Vents, Protrusion Flashing & Seals: Condition: Good Comments: None</p>	<p>No Problem</p>
<p>5</p>	<p>Flashing & Bird-stops: Condition: Good Comments: None</p>	<p>No Problem</p>
<p>6</p>	<p>Observable Evidence of Leaks: Comments: None</p>	<p>No Problem</p>
<p>7</p>	<p>Chimney: Limitations: None Material Type: Brick Condition: Good Comments: None</p>	<p>No Problem</p>
<p>8</p>	<p>Chimney Cap: Material Type: Missing Condition: Missing Comments: Recommend repair.</p>

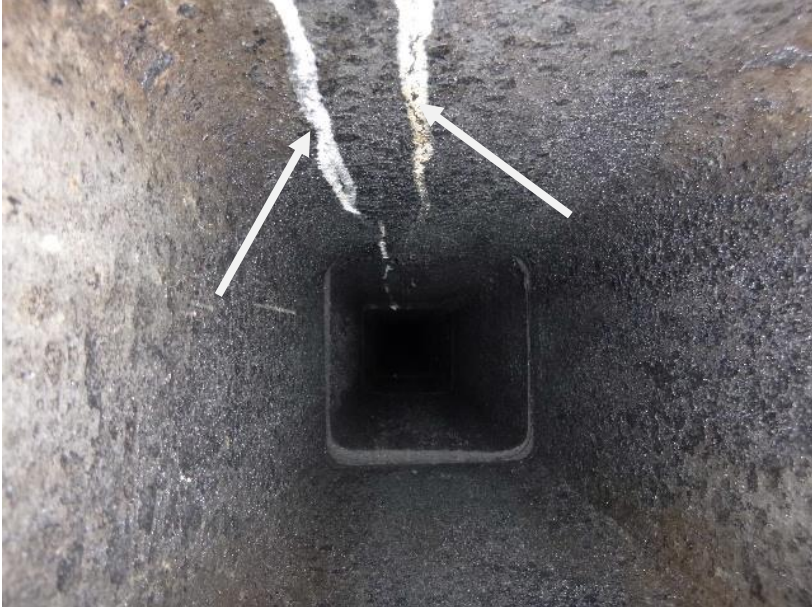
<p>9</p>	<p>Chimney Flue Liner: Material Type: Brick Condition: Cracks - Minor <i>They appear to have been sealed at one time.</i> Comments: Recommend an evaluation by a reputable chimney sweep.</p>

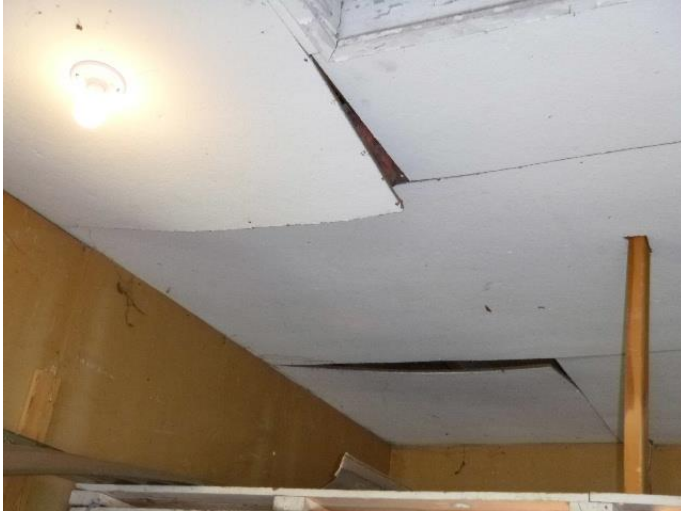
Comments: **Damage - Minor Probably due to water damage at one time. Consider repair.**

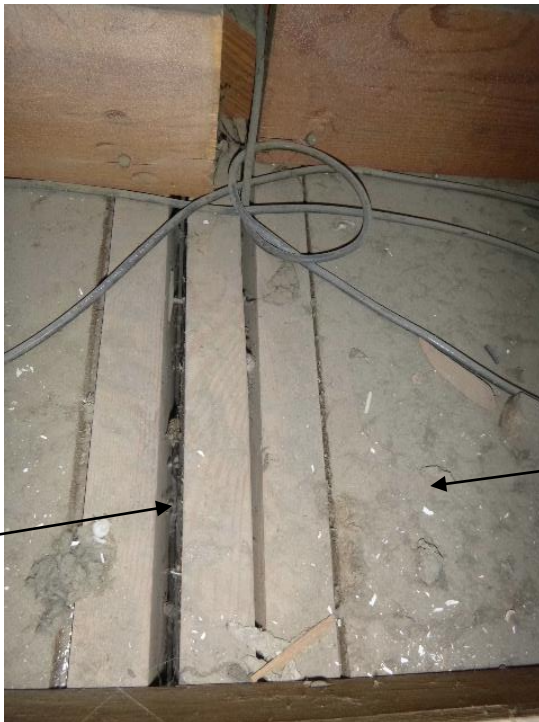
Beam above garage is separating. Pic is a view from the attic of the 3 2x12s that are separating. Recommend repair to draw this beam back together.

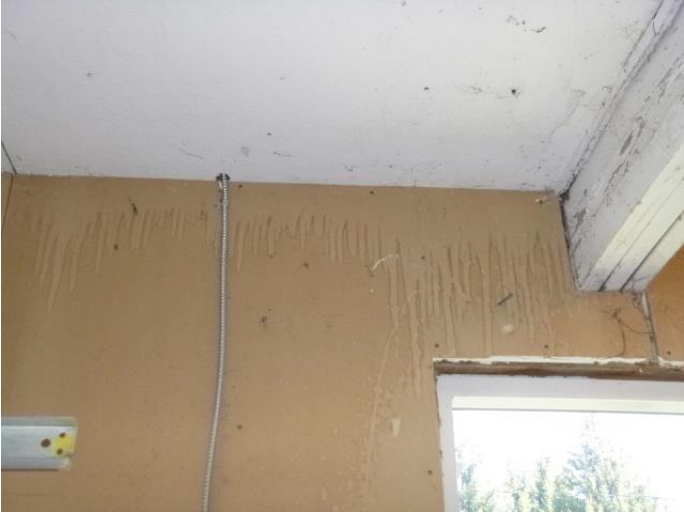
<p>2</p>	<p>Walls: Type: Drywall Comments: Damage - Minor (From pet) Also noted is old water staining.</p>

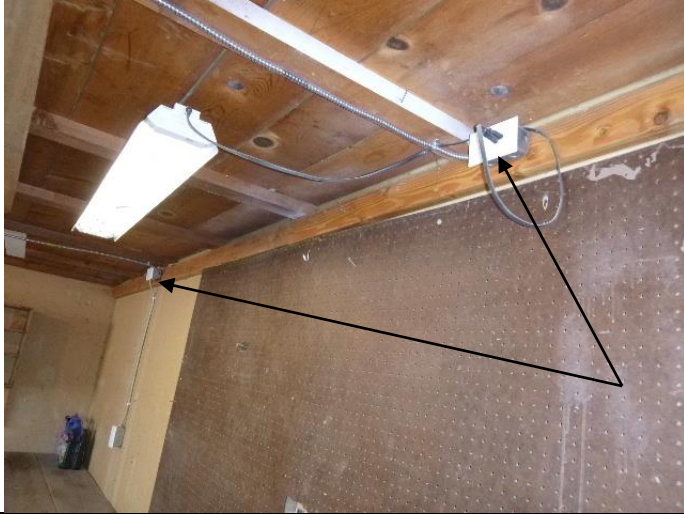
Quantity: **7** GFCI Protected? **Yes , on some**
Test Normal? **No** Condition: **Open ground - upper outlets, east wall**

Comments: **"Open grounds" are typical in older homes that have 2-conductor wiring, when the original 2-slot outlet is replaced with a modern 3-prong outlet. See info. regarding this in the back of the report.**

These 2 outlets also do not have GFCI protection. Consider a GFCI upgrade. See Information regarding GFCI safety in the back of this report.

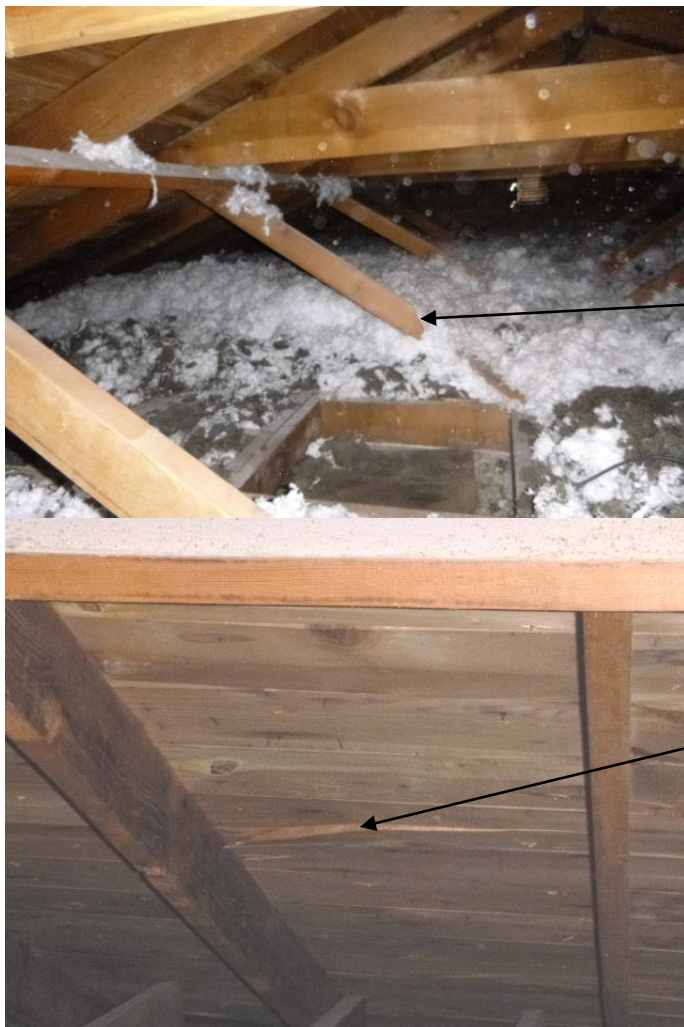
Observed Defects: **One truss support has been cut. Recommend repair to ensure longevity of the roof support structure. (top pic)**

Observed Defects: **Cracked/ Broken Members – minor crack noted on one skip board plank, on the west plane, above the garage. Recommend repair/re-enforce this area.**

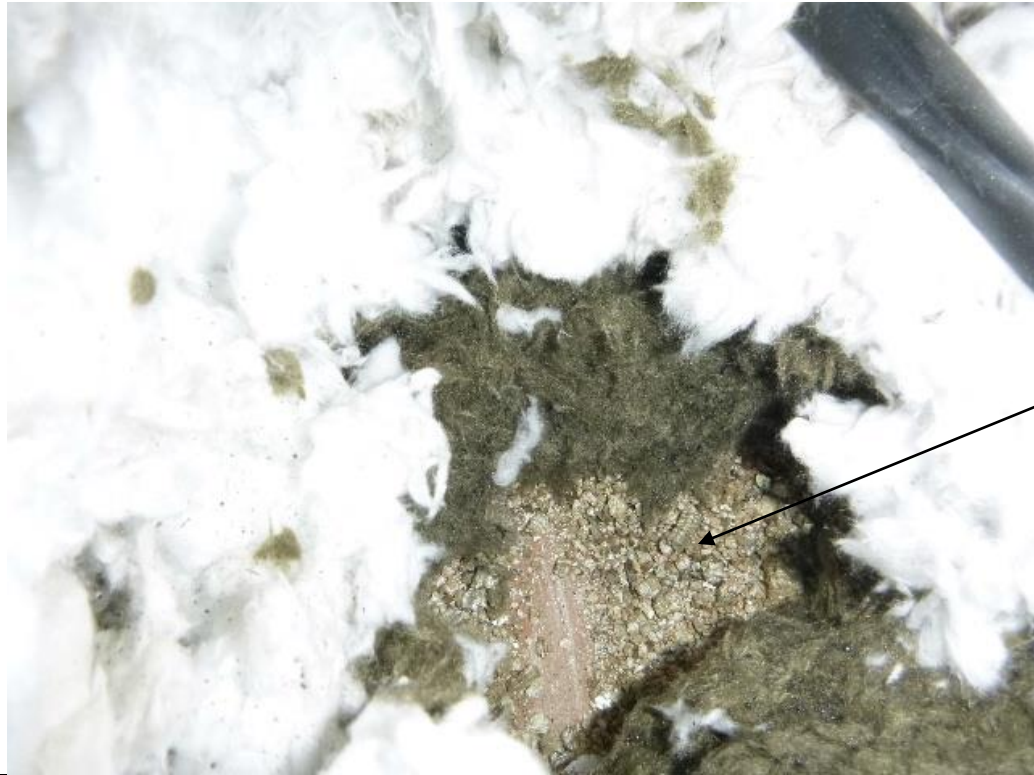
3	Insulation: Type: Loose-fill Material: Vermiculite, Rock wool * Fiberglass Thickness (average): 13 inches Approximate R-Value: 27-38 Condition: Unevenly spread Missing in areas – minor – above the kitchen. Comments: Please read the information regarding Vermiculite in the "additional Information" for this report. Consider "evening out" the insulation in the disturbed areas to avoid cold spots.	Concern X

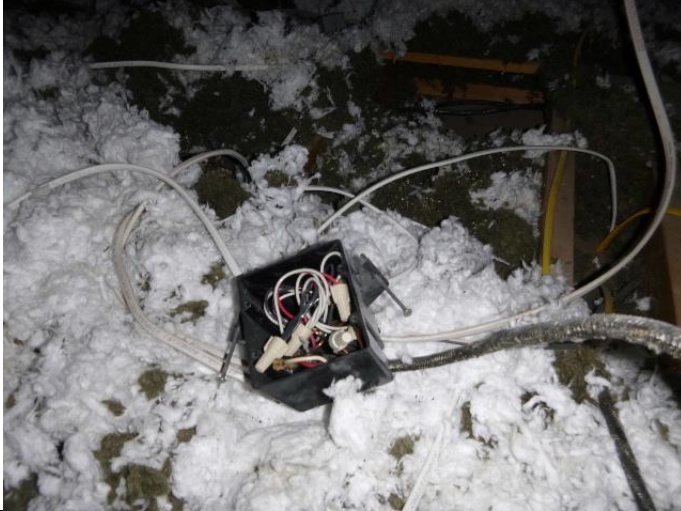
Condition: **Uncovered loose electrical junction box.**

Comments: **Recommend cover and secure for safety.**

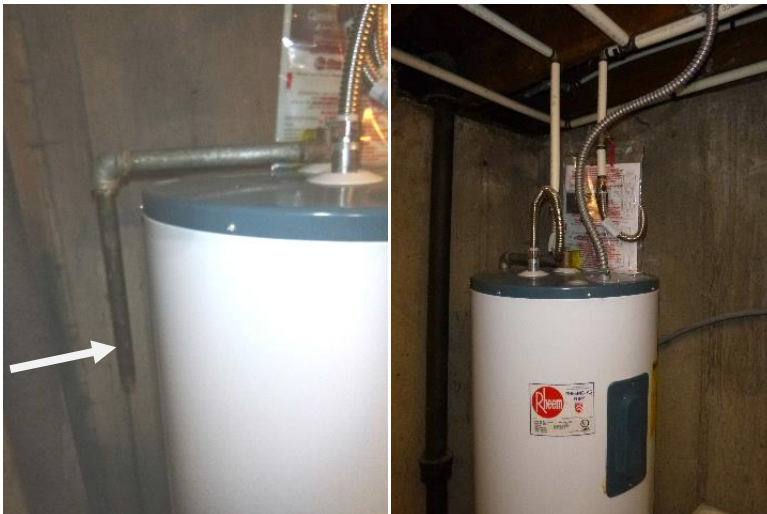
Condition: **Good , a little noisy when heating – Consider flushing to remove sediment.**

Earthquake Strap: **Missing, consider installing for added safety.**

Temperature-Pressure Relief Valve (P.R.V.) Discharge Tube: **Installed, but the length is short. Recommend install a tube of correct length.**

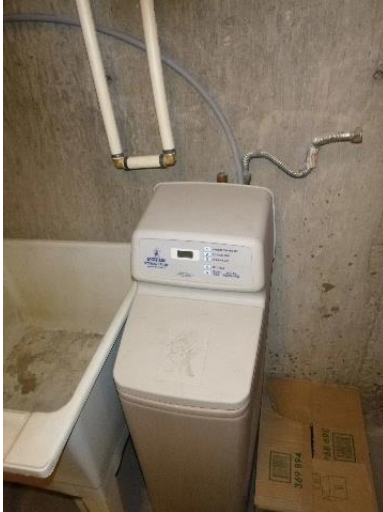
Present operating mode: **Disconnected**

Appear functional?: **No**

Comments: **Recommend check with owner regarding the status of the softener.**

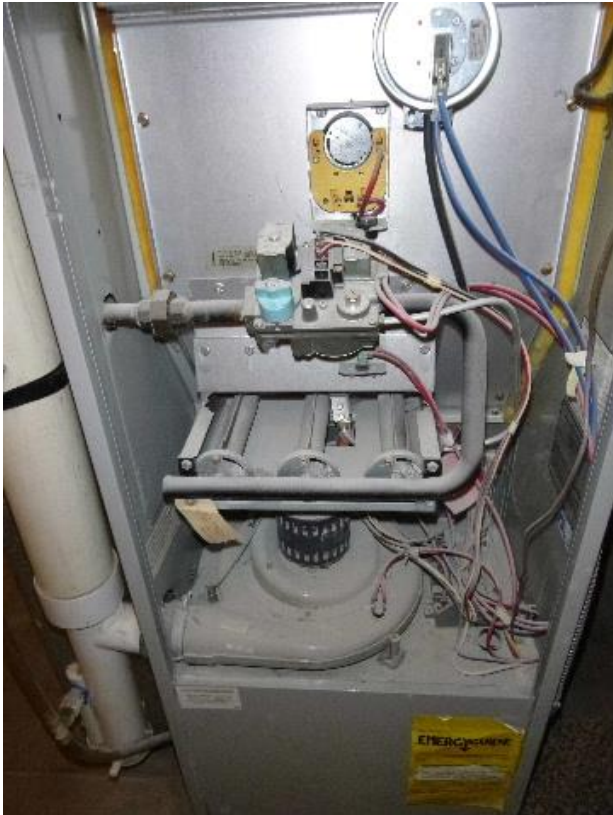
System Type: Central Forced Air .	
Manufacturer: Heil	
Fuel Type: Natural Gas	
1	Furnace / Heating: Concern X
Location: Basement .	
Combustion Air Availability: Appears normal	
Fresh Air Intake: Appears secure and properly installed.	
Venting: Good .	
Service Line Condition: Good .	
Condensate Drains and Pump: Good .	
Air Filter Type: Disposable Condition: Moderately Dirty Size: 20 X 25 X 1"	
Overall Furnace/Heaters Condition: Moderately Dirty Fan is a little noisy	
Furnace/Heating operation: Appears to function normally Since the furnace has some years usage, consider having the "Annual cleaning and maintenance" performed before taking possession.

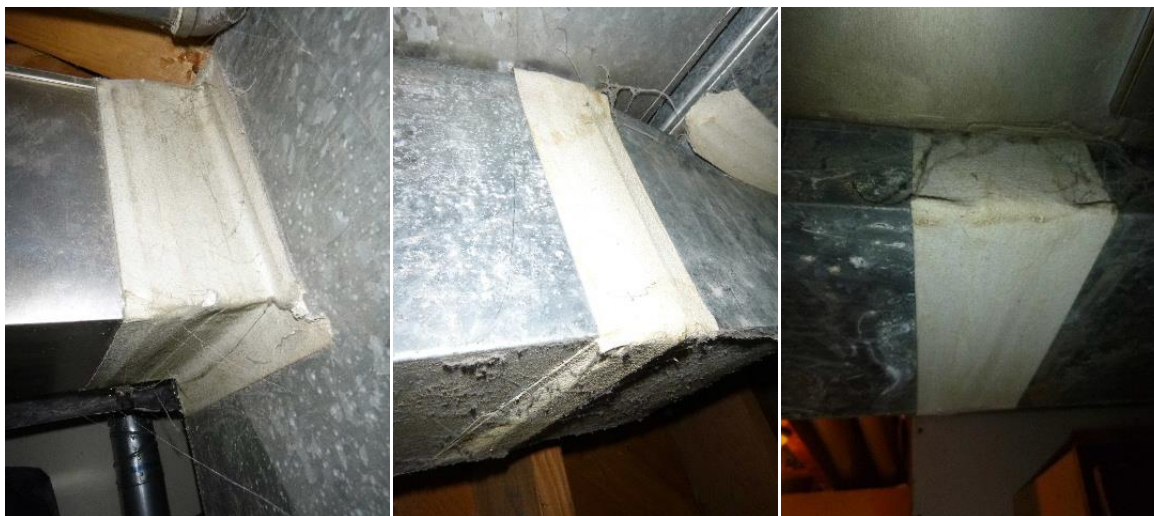
1	Ductwork <i>Possible asbestos containing material - Tape used to seal the duct system.</i> <i>Page: 36</i>
----------	---

3	Ducts: Concealed? <i>Mostly</i> Type: <i>Metal</i> Insulated? <i>n/a</i> Condition: <i>Good</i> Clean? <i>Visibly slightly dirty at the register(s)</i> Comments: <i>The type of tape used to seal the duct system most likely contains asbestos(ACM). The only way to be 100% sure that it does or does not contain asbestos is to have it tested by a qualified EPA and State certified testing company.</i> <i>As the new owner you need to be aware that if this material needs to be removed, it may need to be done by a professional abatement contractor. More information regarding asbestos in the home is available at: http://www.cpsc.gov/cpsc/pub/pubs/453.htm</i>	Major Concern X X
----------	--	--------------------------

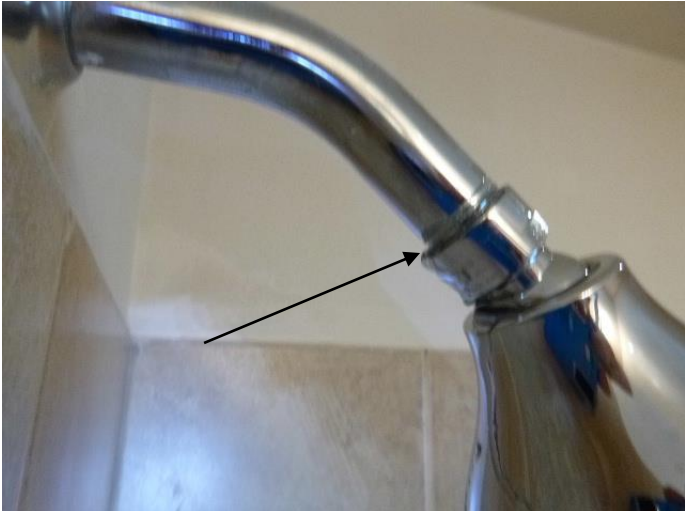
<p>7</p>	<p>Cabinets & Shelving: Condition: Good Comments: None</p>	<p>No Problem</p>
<p>8</p>	<p>Sink & Faucet: Condition: Good Comments: None</p>	<p>No Problem</p>
<p>9</p>	<p>Tub / Shower: Condition: Shower head connection(s) are leaking Comments: Consider repair.</p>

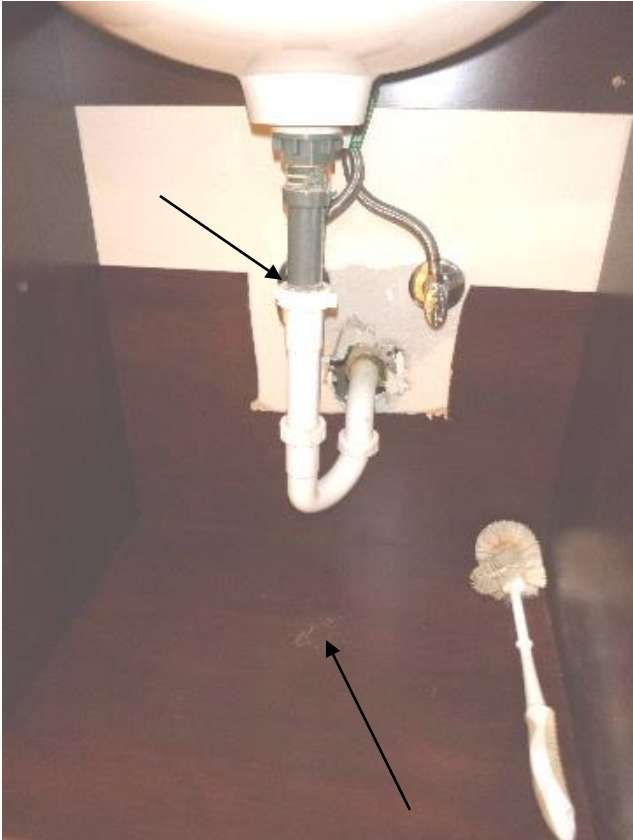
<p>11</p>	<p>Shut-Off Valves & Drain Traps:</p> <p>Shut-off Valve(s): Good</p> <p>Drains & Trap(s): Leak traces noted, but not presently leaking.</p> <p>Comments: Evidence of leakage noted, but not presently leaking, recommend monitor, consider repair to ensure reliability.</p>

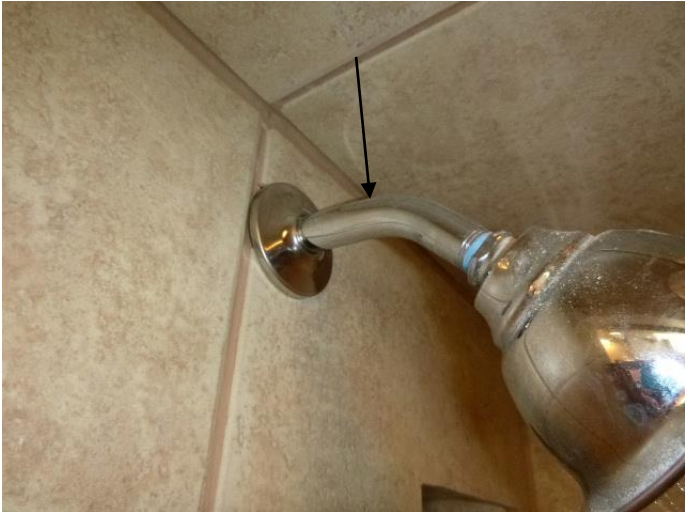
<p>8</p>	<p>Sink & Faucet: Condition: Good Comments: None</p>	<p>No Problem</p>
<p>9</p>	<p>Shower: Condition: Shower head pipe is loose. Recommend secure.</p>

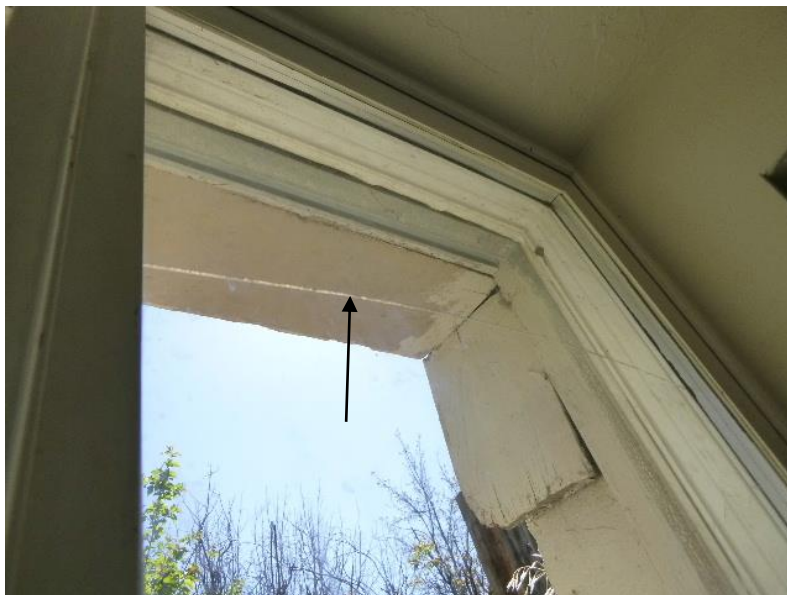
<p>1</p>	<p>Door(s): Door Condition: Good Latch(s) Condition: Good Comments: None</p>	<p>No Problem</p>
<p>2</p>	<p>Ceiling: Comments: Appears to be in good condition.</p>	<p>No Problem</p>
<p>3</p>	<p>Walls: Molding & Trim: Good Comments: Appear to be in good condition.</p>	<p>No Problem</p>
<p>4</p>	<p>Window(s): Pane: Double Pane Condition: Crack(s) - Minor East window Frame: Vinyl Frame Condition: Good Window Operation: Stiff Operation - Consider cleaning tracks and mechanisms. East window Screen Condition: Missing East window Treatments / Shades: Missing Comments: Consider repair.</p>	<p>Concern X</p>

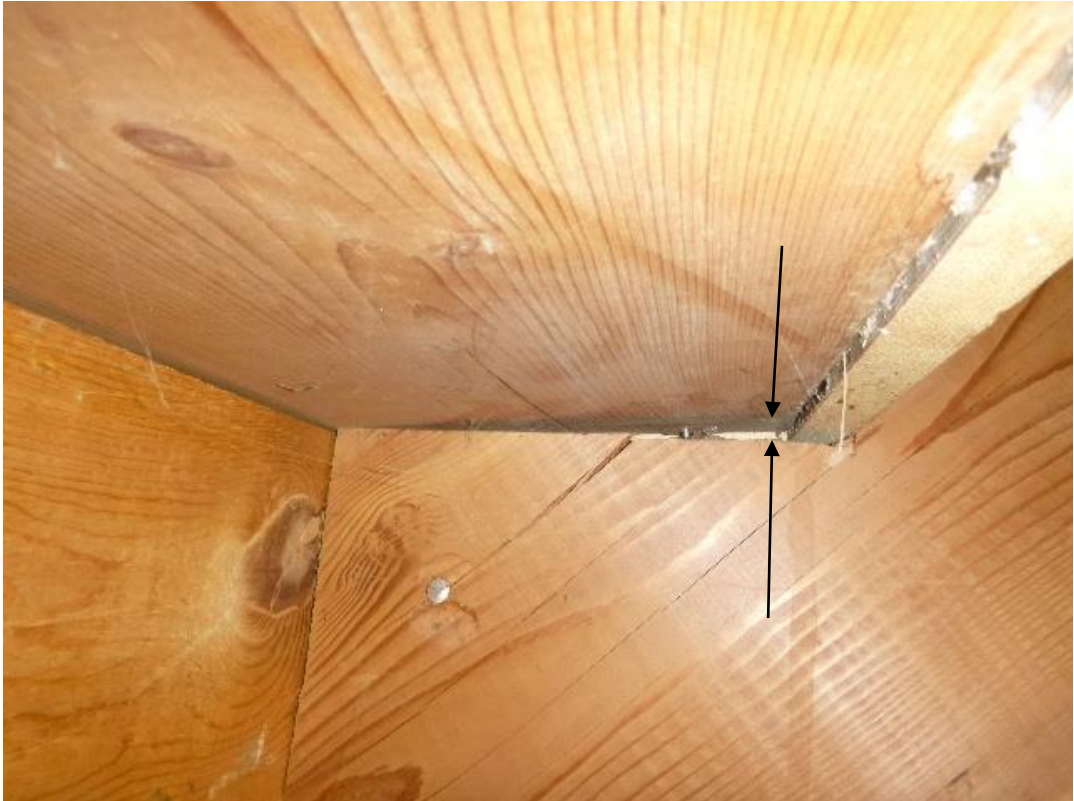
<p>1</p>	<p>Ceiling: Comments: <i>Appears to be in good condition.</i></p>	<p>No Problem</p>
<p>2</p>	<p>Walls: Molding & Trim: Good Comments: <i>Appear to be in good condition.</i></p>	<p>No Problem</p>
<p>3</p>	<p>Flooring: Type: Carpet Condition: Good Comments: None</p> <p>Sub-Flooring: Condition: Good, but the 7th step from the bottom is leaning forward. Comments: Recommend repair for safety. Pic shows gap under stair.</p>	<p>Concern X</p>

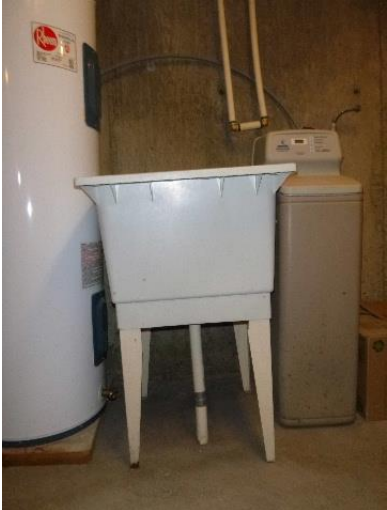
<p>1</p>	<p>Sink & Faucet: Condition: Not connected up. Comments: Consider repair.</p>

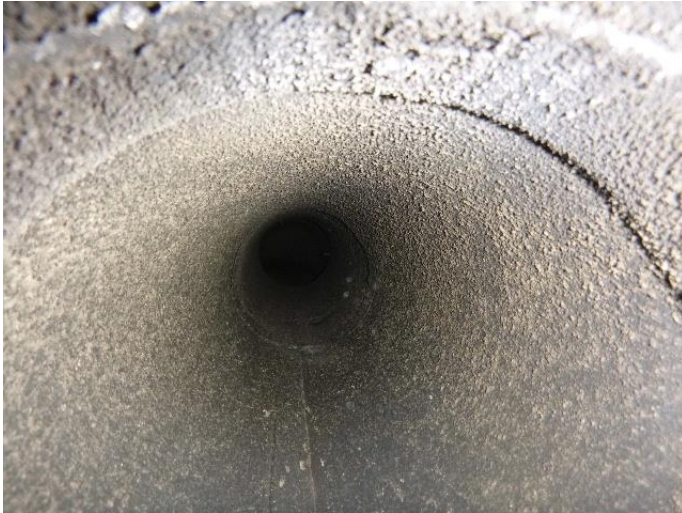
5	Fireplace / Woodstove / Chimney: <i>Wood stove and chimney appear to be in good condition.</i> <i>Chimney has light buildup of creosote. Chimney flue appears to have 2 cracks.</i> <i>Recommend have a qualified chimney sweep clean and inspect before firing. Pic shows bottom of stove pipe.</i>	Concern X
6	Hot Water Temperature : Measured temperature: 125° F (Approximate reading) Comments: Consider lowering the temperature to 120 degrees for safety.	Minimal Concern

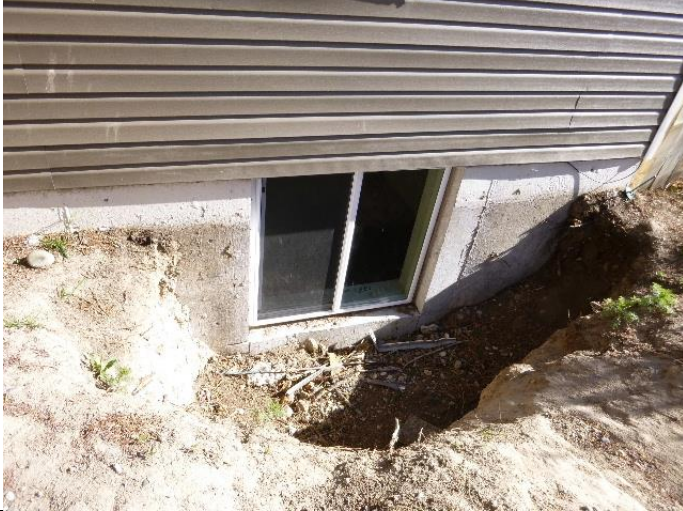
Well Depth: n/a" Egress window well has not been installed at this time.

Consider installing ladder(s) for safety.
